## Failure investigation into the boiler tubes of power plant

### Abstract

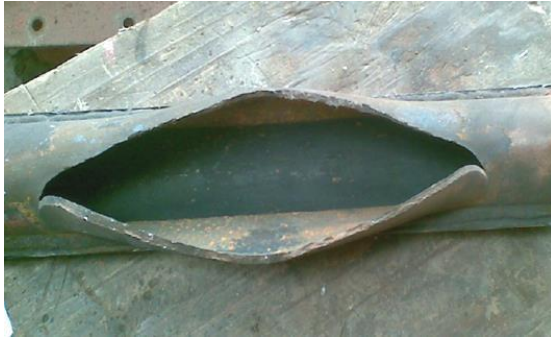
A boiler tube, made of SA-210 Grade A-1 steel (ASTM A 210) [3], ruptured within one year of its service period (as shown in Figure 1). The header tube was found to be blocked (clogged) due to scale formation (as shown in Figure 2). A study was conducted to determine the cause of rupture.

**Figure 1** Ruptured boiler tube

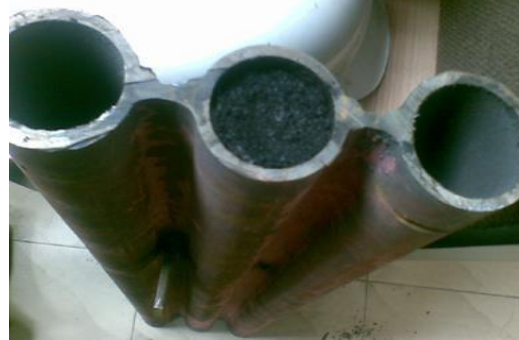
**Figure 2** Blocked header tube

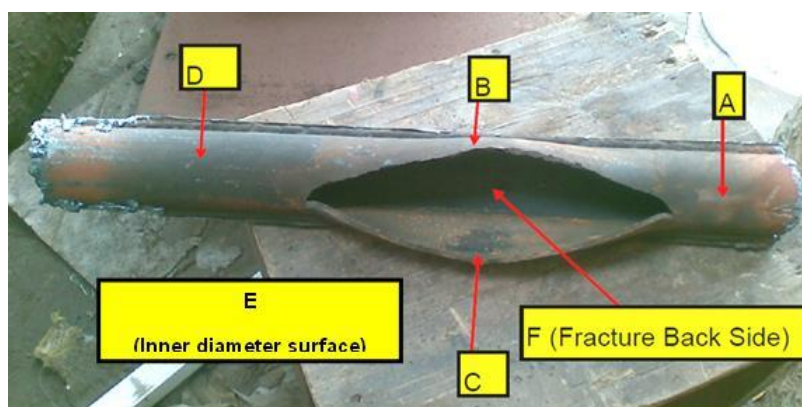
The samples were extracted from the rupture zone as well as from the unaffected zone of boiler tubes for analysis (as shown in Figure 3).

**Figure 3** Locations of extracted samples of the boiler tube

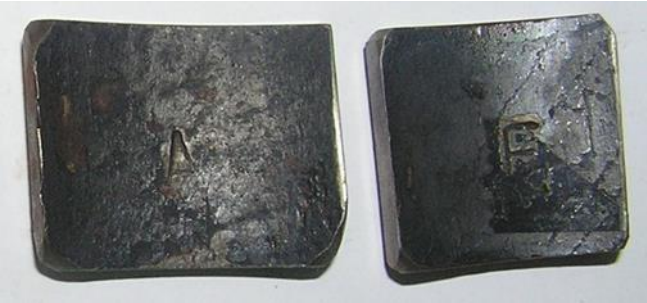
First of all, as received samples of tube were examined visually. A dark layer was observed on the inner surface of sample A & F, which are from the undamaged areas of the boiler tube (as shown in Figure 4). But it was not found on the inner surface of sample B & C, which are from the surrounding areas of the fractured location. However, the corrosion was observed on the inner surface of sample B & C (as shown in Figure 5).

Figure 4 Oxide layer (scale) on the inner surface of sample A & F

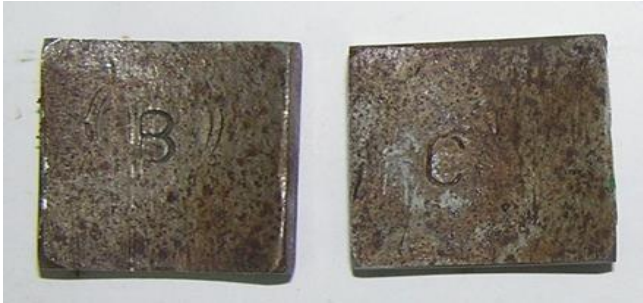
Figure 5 Corrosion on inner surface of sample B & C

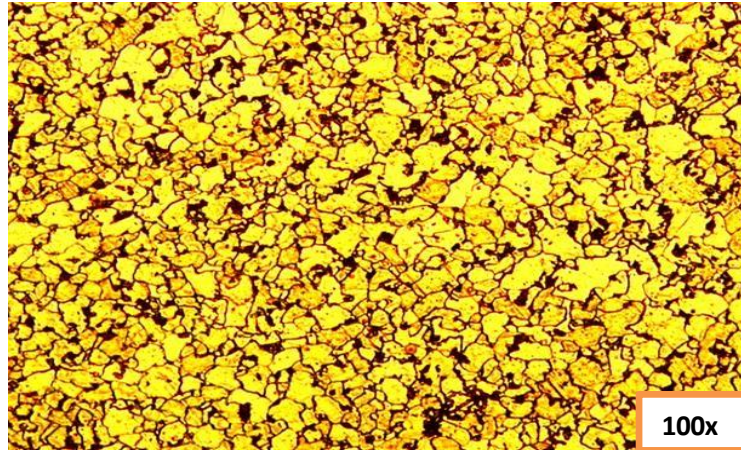
The microstructure of transverse cross-sectional surfaces of samples A, B, C & F appears to be consisted of ferritic matrix with uniform distribution of pearlite (as shown in Figure 6). Whereas; the microstructure of longitudinal cross-sectional surfaces of sample A, B, C & F appears to be consisted of ferritic matrix with banded pearlite (as shown in Figure 7).

**Figure 6** Transverse cross-sectional micrograph showing ferrite & pearlite.

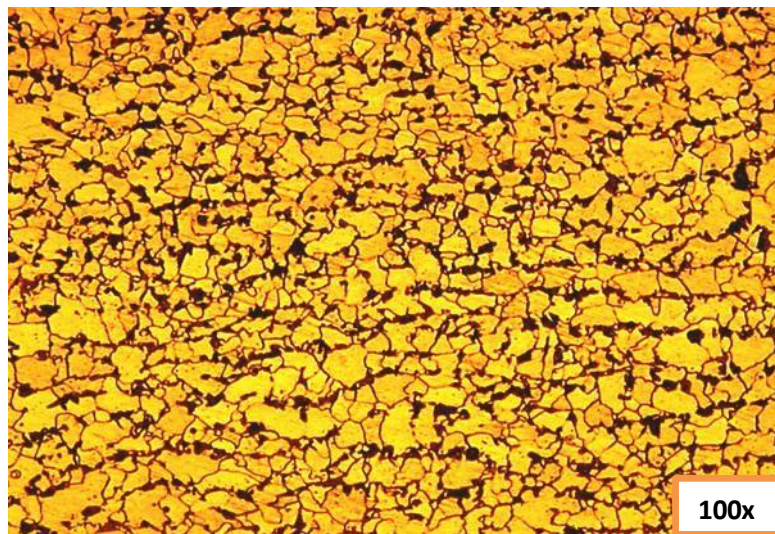
**Figure 7** Longitudinal cross-sectional micrograph showing ferrite & banded pearlite

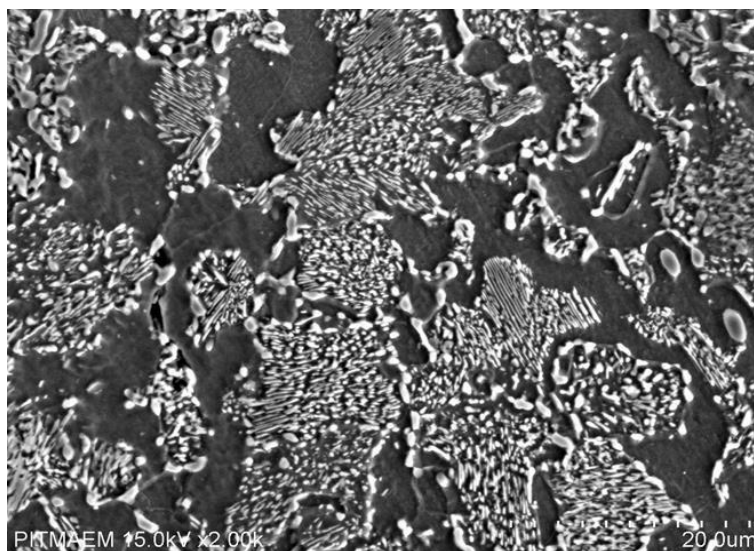
The microstructure of the inner surface near the fractured region of sample E appears to be of ferritic matrix with relatively non-uniform distribution of pearlite (as shown in Figure 8 & 9). As mentioned earlier in Section 2.7, ID surface of boiler tube experienced some grain growth due to over-heating (as shown in Figure 9). It was observed that this non-uniformity in grain size & pearlite distribution might be playing a role in the eventual failure of boiler tube.

**Figure 8** SEM micrograph showing ferrite and lamellar structure of pearlite

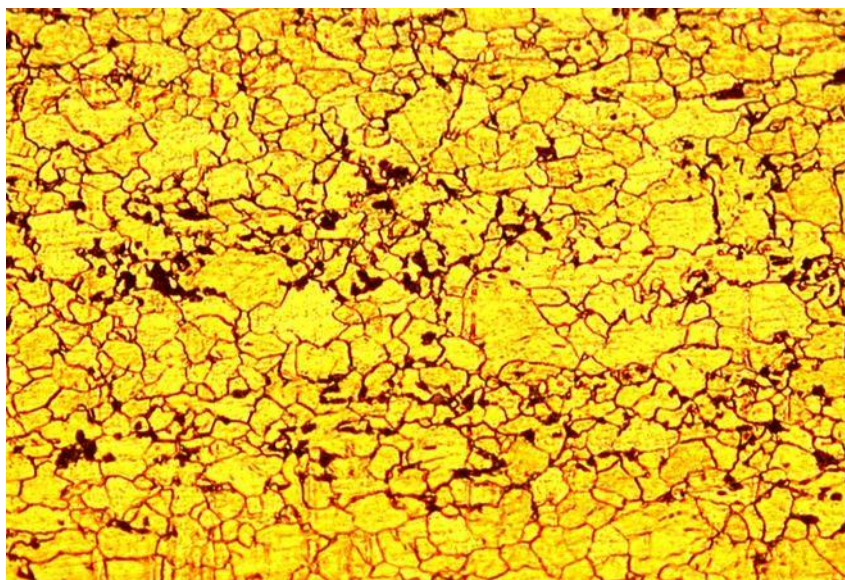
**Figure 9** Cross-sectional micrograph showing grain growth and non-uniform distribution of pearlite

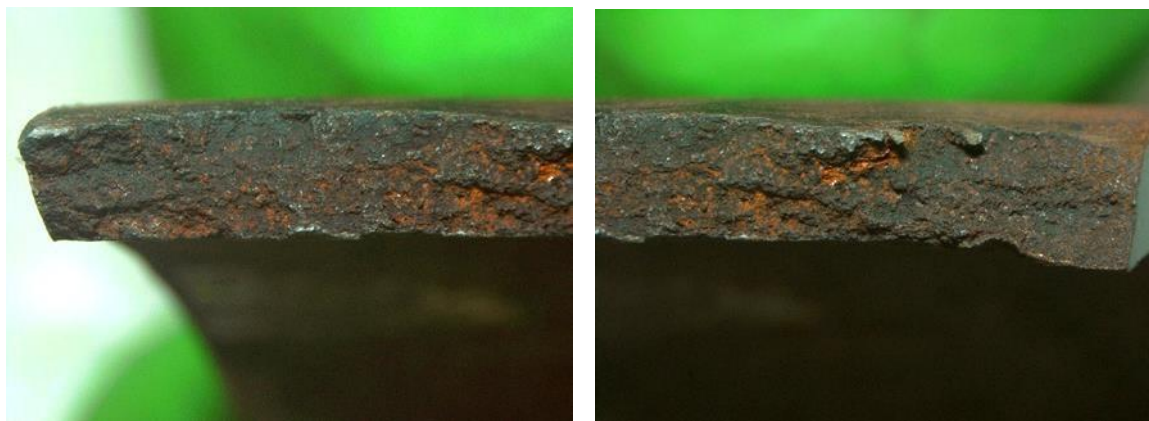
Fractography was performed via Optical Microscopes (Zoom Microscope, SZX7, Olympus, Japan; DM4000M Image Analyzer, Leica, Germany), on the fractured regions of sample B. The fracture surface appears to be of brittle nature with negligible amount of plastic deformation (as shown in Figure 10). The outer diameter surface of sample B reveals cracks as indicated by arrows, which appeared to be formed during fracture (as shown in Figure 11). Transverse cross-section of fractured zone of boiler tube indicated intergranular fracture (as shown in Figure 12).

**Figure 10** Fracture surface of sample B

On the basis of above mentioned results and discussion, it was concluded that, the brittle fracture (rupture) of tubes was occurred due to over-heating caused the formation of thermally insulating thick iron oxide scale on the inner surface of the boiler tube. This may be prevented by proper maintenance of tubes.

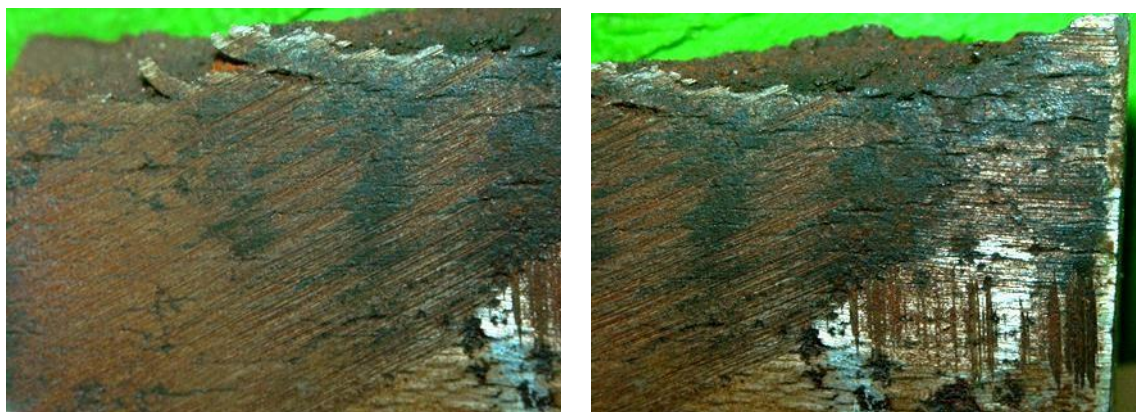
**Figure 11** Top surface of sample B

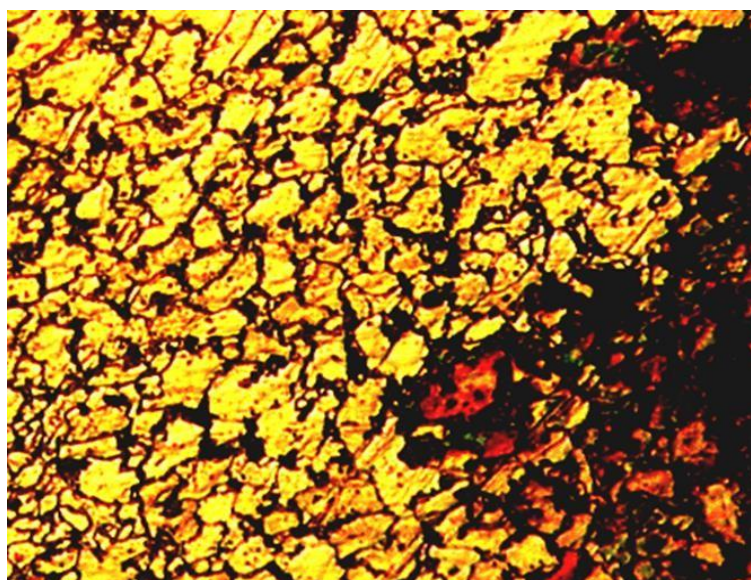
**Figure 12** Transverse cross-sectional micrograph of fractured zone of boiler tube showing intergranular fracture of boiler tube (sample B)
